TEST REPORT

ENVIRONMENTAL TESTING

Report reference No...... : 19630550 001

Test item description..... : Classic Solar Power Conditioning Unit with inbuilt MPPT charge Controller

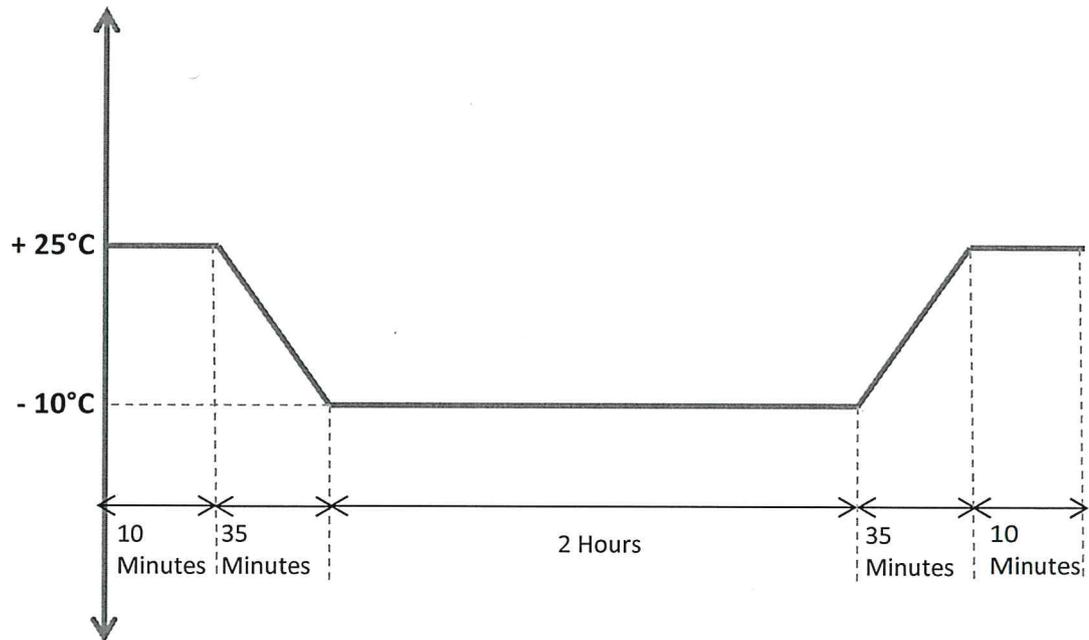
Graph:

EUT Operating Condition	Powered OFF	-
	Test Temperature	- 10°C	-
	Dwell Time	2 Hours	-
	No. of cycles	1 Cycle	-

1.3	Post check: Examination after environmental conditioning		P
1.3.1	Physical damages	No physical damages were observed	P
1.3.2	EUT working condition	EUT was working fine after the cold test	P

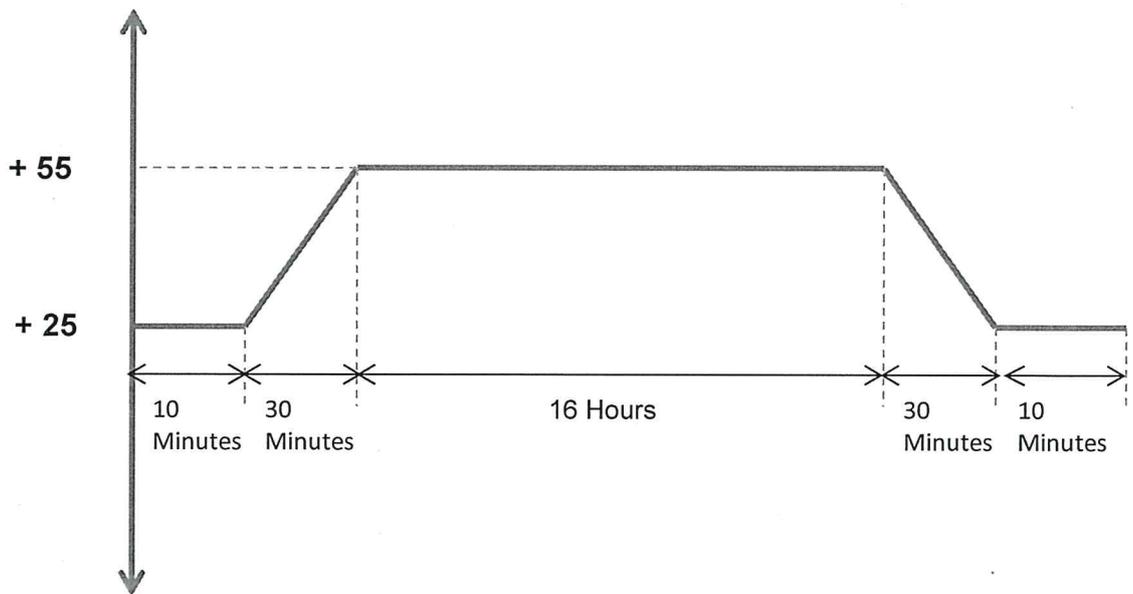
Graph:

EUT Operating Condition	Powered OFF	-
	Test Temperature	+55°C	-
	Dwell Time	16 Hours	-
	No. Of cycles	1 Cycle	-

2.3	Post check: Examination after environmental conditioning		P
2.3.1	Physical damages	No physical damages were observed.	P
2.3.2	EUT working condition	EUT was working fine after the dry heat test	P

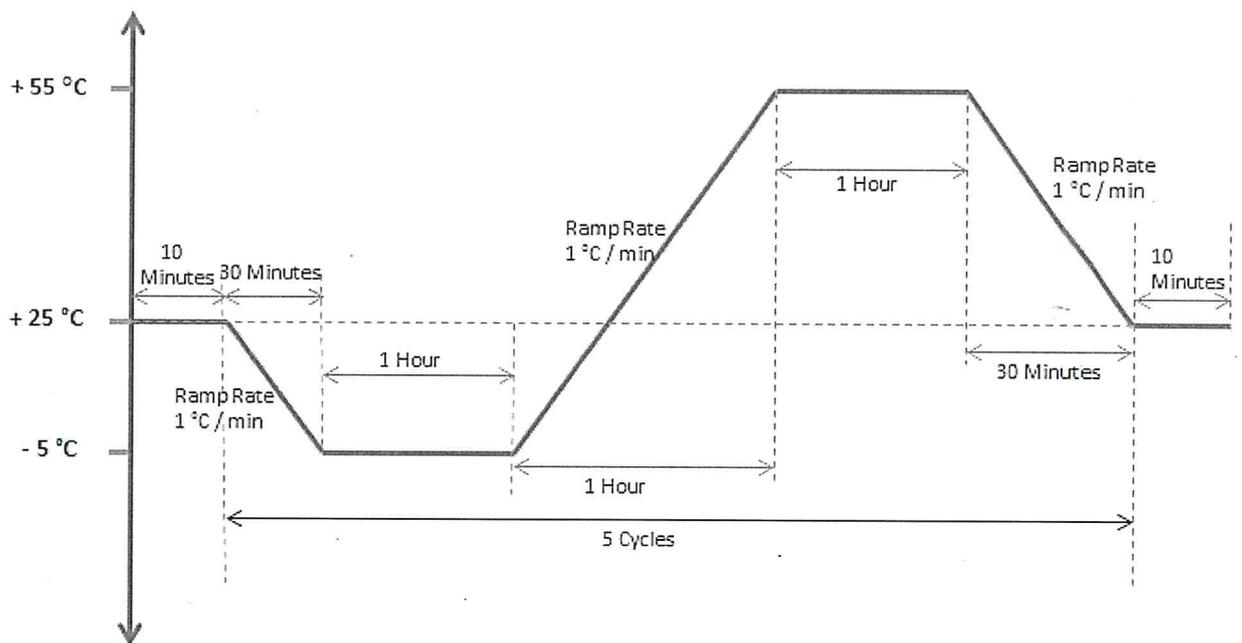
Graph:

EUT Operating Condition	Powered OFF	-
	Test Temperature	Upper: +55° C Lower: -5°C	-
	Rate of change of temperature	1°C/min	-
	Dwell Time	1 Hour at each temperature	-
	No. of cycles	5 Cycle's	-

3.3	Post check: Examination after environmental conditioning		P
3.3.1	Physical damages	No physical damages were observed	P
3.3.2	EUT working condition	EUT was working fine after the change of temperature test.	P

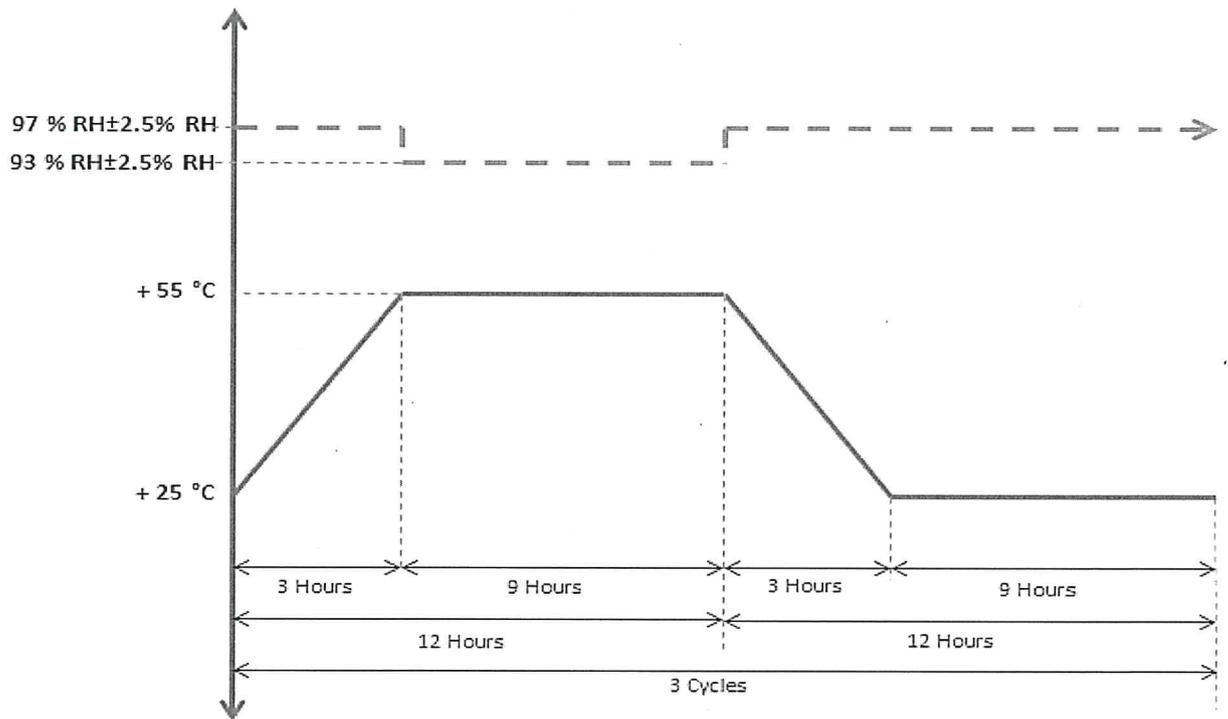
Graph:

EUT Operating Condition	Powered OFF	-
	Ramp -up / -down time	3 Hours	-
	One Cycle duration	12 Hours +12 Hours	-
	No. of cycles	3 Cycle's	-
	Total Test Duration	72 Hours	-

4.3	Post check: Examination after environmental conditioning		P
4.3.1	Physical damages	No physical damages were observed.	P
4.3.2	EUT working condition	EUT was working fine after the damp heat cyclic test.	P
