Prüfbericht - Nr.: *Test Report No.:*	**19630485 001**		**Seite 1 von 10** *Page 1 of 10*
Auftraggeber: *Client:*	**Solar Idea Pvt. Ltd.** 8-2-277/A/7, Plot No.126, Road No.2, Banjara Hills, Hyderabad – 500034, Telangana, India		
Gegenstand der Prüfung: *Test item:*	Classic Solar Power Conditioning Unit with inbuilt MPPT charge Controller		
Bezeichnung: *Identification:*	3000VA	**Serien-Nr.:** *Serial No.:*	101505001571
Wareneingangs-Nr.: *Receipt No.:*	1803110293	**Eingangsdatum:** *Date of receipt:*	2015.12.22
Prüfort: *Testing location:*	**TÜV Rheinland (India) Pvt. Ltd.** Plot No.17B, Electronic City Phase II Industrial Area, Hosur Road Bangalore - 560 100, Karnataka, India		
Prüfgrundlage: *Test specification:*	IEC 60068-2-30, IEC 60068-2-14, IEC 60068-2-1, IEC 60068-2-2 (As per MNRE / customer requirement).		
Prüfergebnis: *Test Result:*	Refer section " Summary of testing"		
Prüflaboratorium: *Testing Laboratory:*	**TÜV Rheinland (India) Pvt. Ltd.** Plot No.17B, Electronic City Phase II Industrial Area, Hosur Road Bangalore - 560 100, Karnataka, India

TEST REPORT

ENVIRONMENTAL TESTING

Test item description	:	Classic Solar Power Conditioning Unit with inbuilt MPPT charge Co

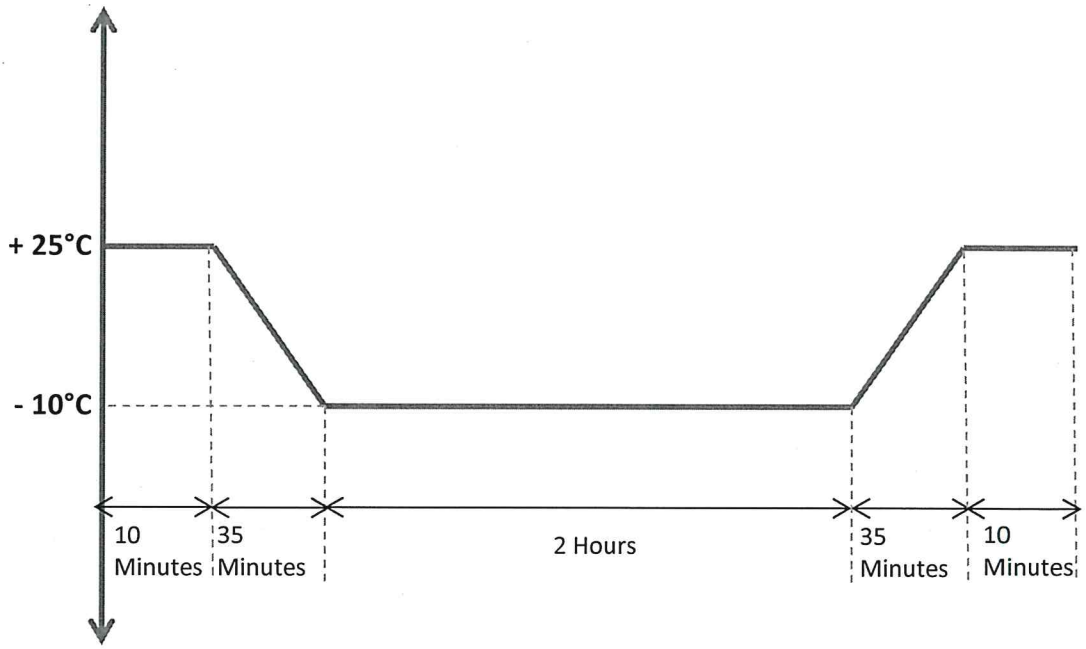
Graph:

EUT Operating Condition	Powered OFF	-
	Test Temperature	- 10°C	-
	Dwell Time	2 Hours	-
	No. of cycles	1 Cycle	-

1.3	Post check: Examination after environmental conditioning		P
1.3.1	Physical damages	No physical damages were observed	P
1.3.2	EUT working condition	EUT was working fine after the cold test	P

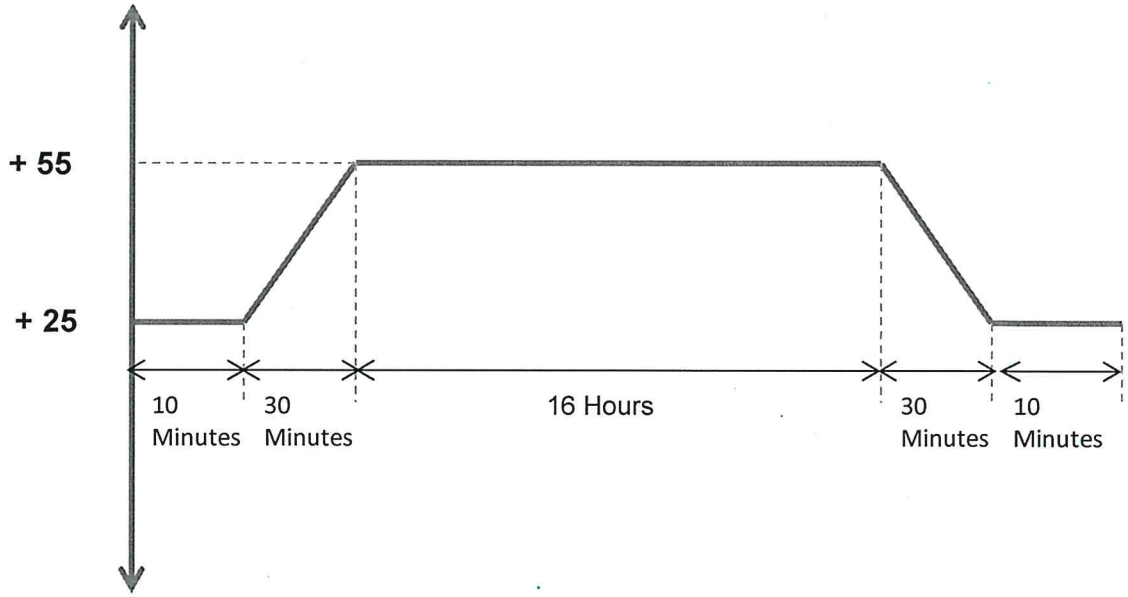
EUT Operating Condition	Powered OFF	-
	Test Temperature	+55°C	-
	Dwell Time	16 Hours	-
	No. Of cycles	1 Cycle	-
2.3	Post check: Examination after environmental conditioning		P
2.3.1	Physical damages	No physical damages were observed.	P
2.3.2	EUT working condition	EUT was working fine after the dry heat test	P

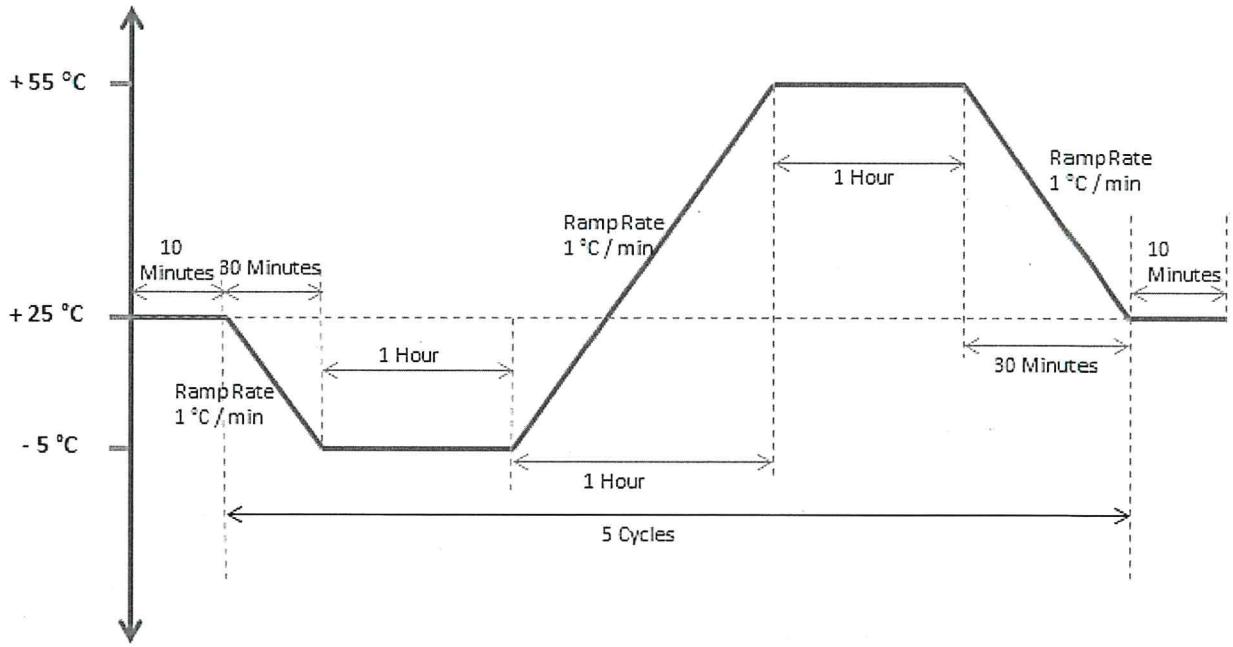
Graph:

EUT Operating Condition	Powered OFF	-
	Test Temperature	Upper: +55° C Lower: -5°C	-
	Rate of change of temperature	1°C/min	-
	Dwell Time	1 Hour at each temperature	-
	No. of cycles	5 Cycle's	-

3.3	Post check: Examination after environmental conditioning		P
3.3.1	Physical damages	No physical damages were observed	P
3.3.2	EUT working condition	EUT was working fine after the change of temperature test.	P

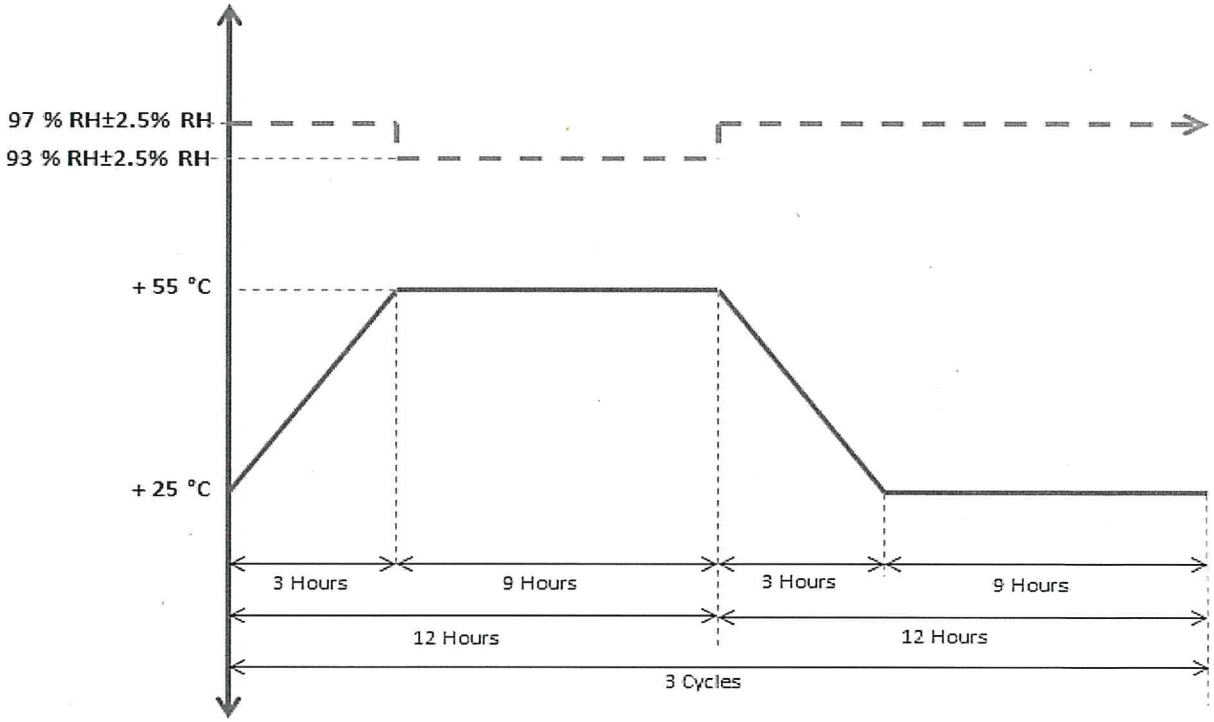
Graph:

EUT Operating Condition	Powered OFF	-
	Ramp –up / -down time	3 Hours	-
	One Cycle duration	12 Hours +12 Hours	-
	No. of cycles	3 Cycle's	-
	Total Test Duration	72 Hours	-

4.3	Post check: Examination after environmental conditioning		P
4.3.1	Physical damages	No physical damages were observed.	P
4.3.2	EUT working condition	EUT was working fine after the damp heat cyclic test.	P
